PARATRANSIT VEHICLE TEST AND EVALUATION

Volume I: Ride Comfort and Quality Tests

1. Report No. UMTA-MA-06-0041-77-10	2. Government Accession No.	3. Recipient's Catalog No.	
4. Title and Subtitle LORAN AUTOMATIC VEHICLE MONITORING SYSTEM, PHASE I Volume I: Test Results		5. Report Date August 1977

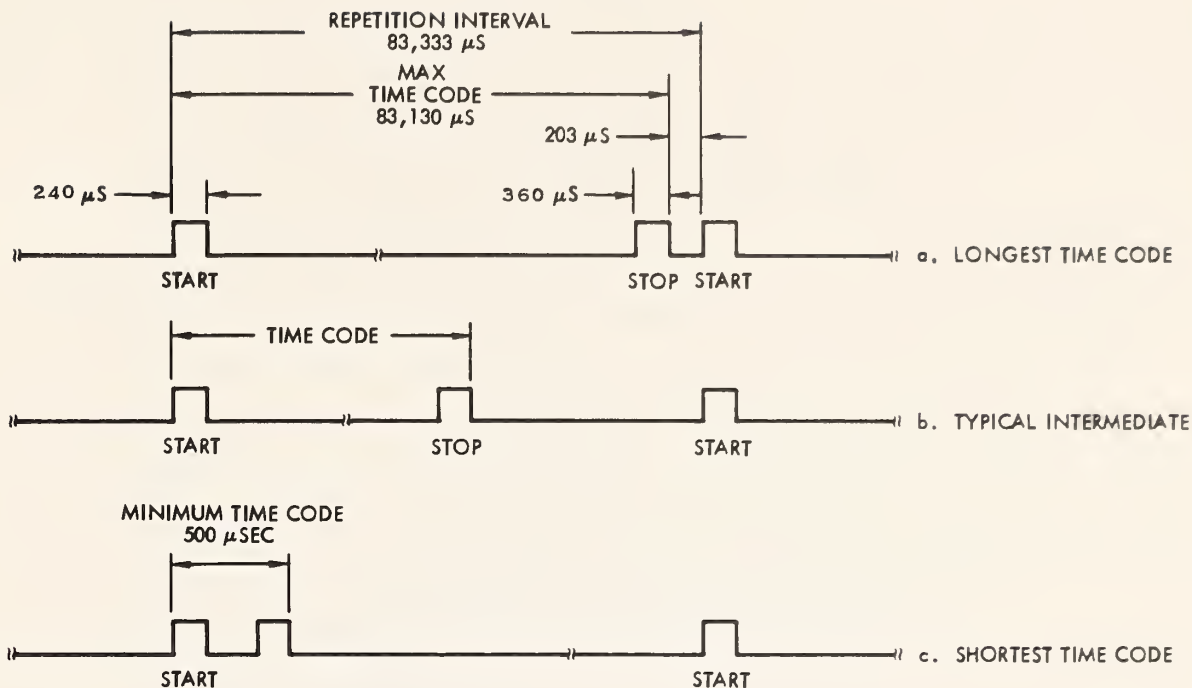
Figure 2-28. Augmentor Timing Code
